THE UNITED STATES  
STRATEGIC BOMBING SURVEY

EFFECTS OF  
THE ATOMIC BOMB  
ON  
NAGASAKI, JAPAN

Physical Damage Division

June 1947

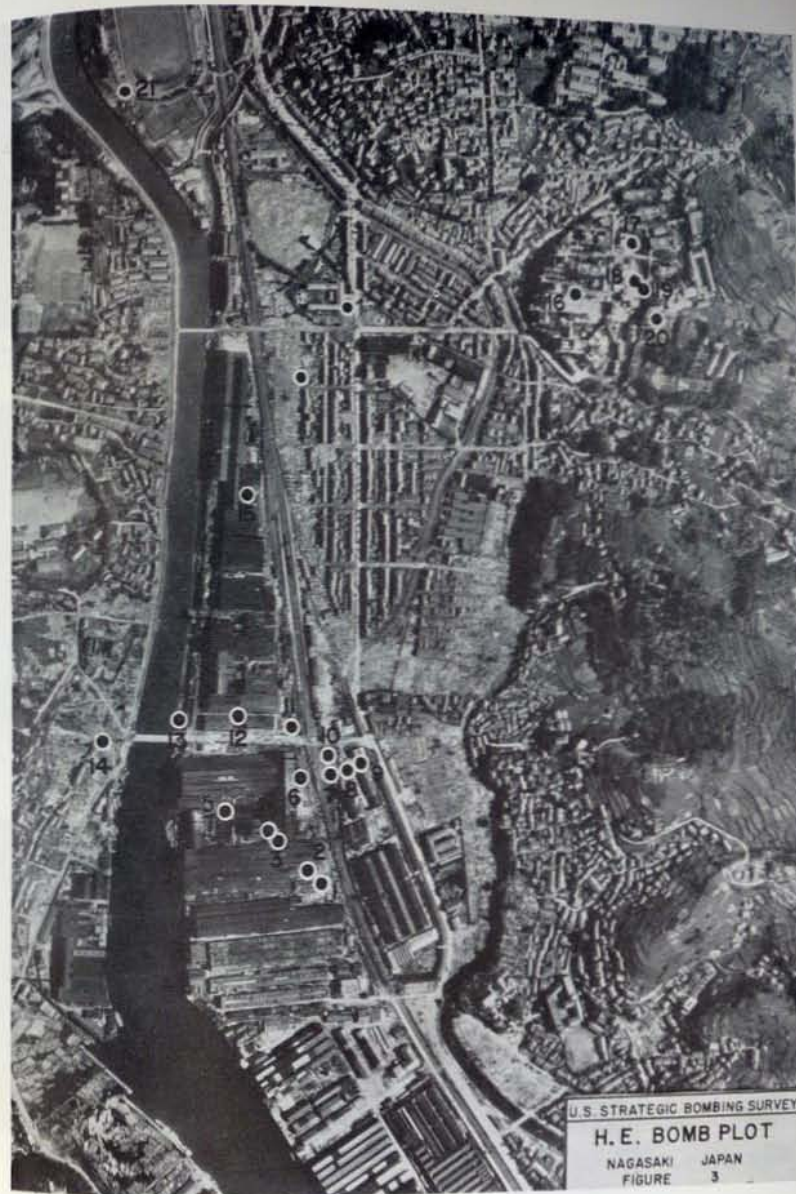
U.S. STRATEGIC BOMBING SURVEY  
H. E. BOMB PLOT  
NAGASAKI JAPAN  
FIGURE 3

**8. High-Explosive Bombs.**—Figure 3 (aerial photo) shows the high-explosive bombs which fell in the Mitsubishi Steel and Arms Plant (Group

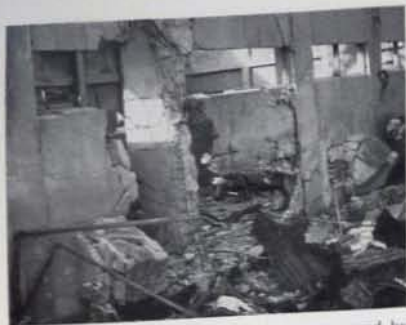
PHOTO 6.—Group 26, Building 32. Damage caused by high-explosive bomb prior to 9 August 1945.

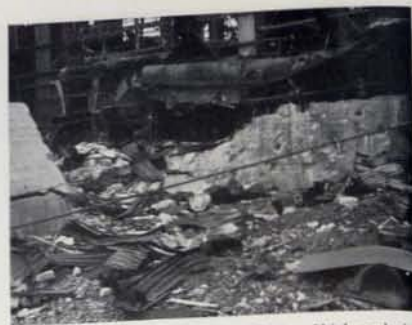
PHOTO 7.—Group 26, Building 19. Crater of high-explosive bomb. No damage caused to building.

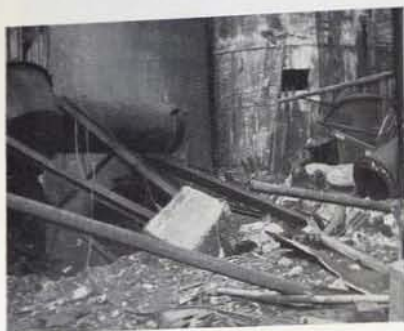
PHOTO 8.—Group 26, Building 23. Damage caused at base of reinforced-concrete stack by high-explosive bomb.

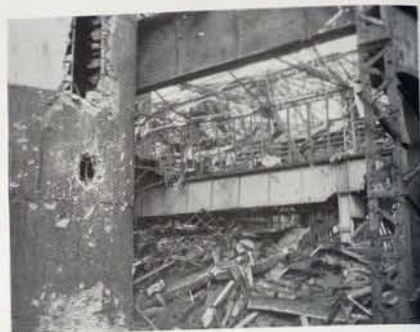
PHOTO 9.—Group 26, Building 16. Frag damage to steel girder and to concrete stack caused by high-explosive bomb.

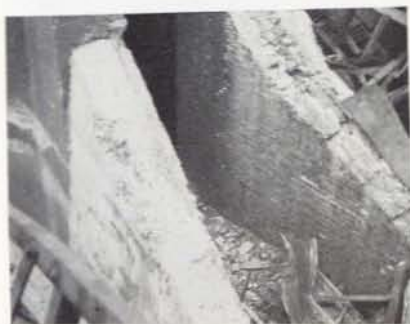
PHOTO 10.—Group 26, Building 16. Damage to foot of concrete stack caused by high-explosive bomb.

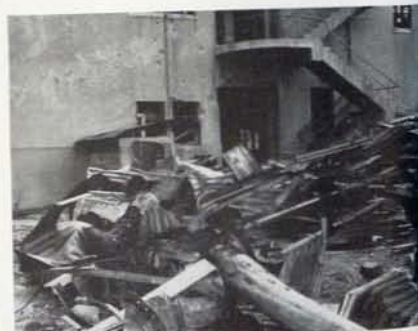
PHOTO 11.—Group 26, Building 13. Frag damaged steel caused by high-explosive bomb at northwest corner of building.

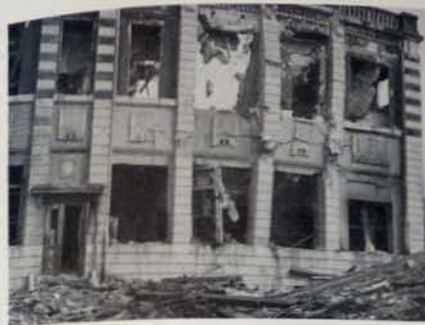
PHOTO 12.—Group 20, Building 17. Damage to concrete building by high-explosive bomb prior to 9 August 1945.

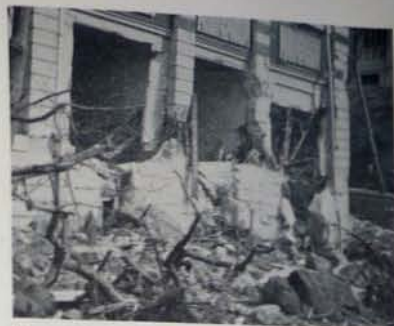
PHOTO 13.—Group 20, Building 18. Crater and damaged concrete columns caused by high-explosive bomb.

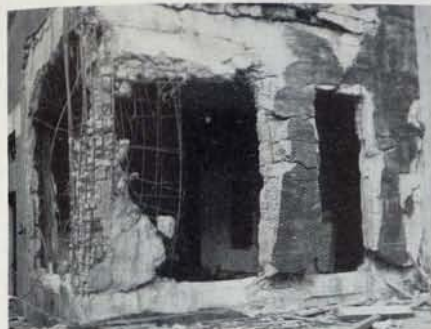
PHOTO 14.—Group 20, Building 32. Damaged at south-east corner of building caused by high-explosive bomb.

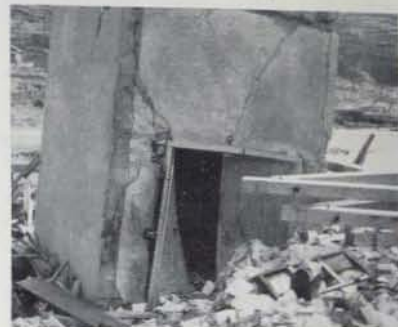
PHOTO 15.—Group 26. Damage to concrete vault east of road caused by high-explosive bomb.

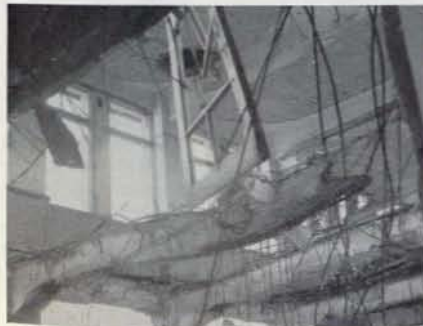
PHOTO 16.—Group 1, Building 7. Damage to third floor caused by high-explosive bomb. Hole of entry shown in roof slab.

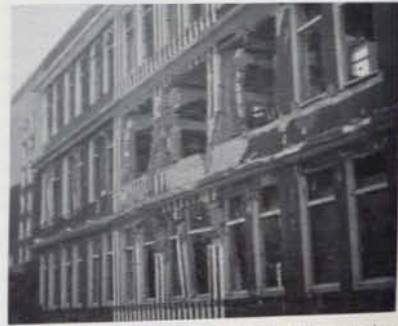
PHOTO 17.—Group 1, Building 7. Damage caused to north wall by high-explosive bomb.

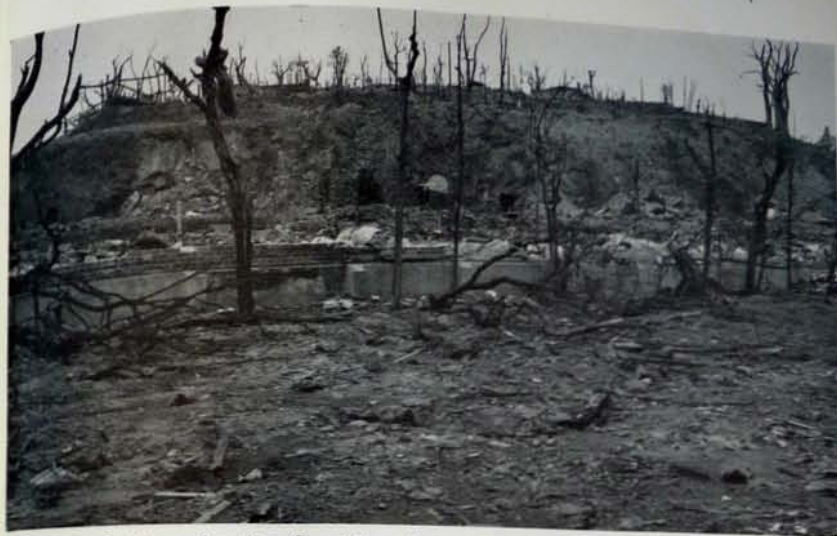
PHOTO 26.—Looking northwest from Ground Zero. Trees were stripped, and branches were broken downward. Low brick wall in the middle distance was demolished. Note cave shelters in the hillside. Nagasaki Prison (Group 13) can be seen in the upper right corner.

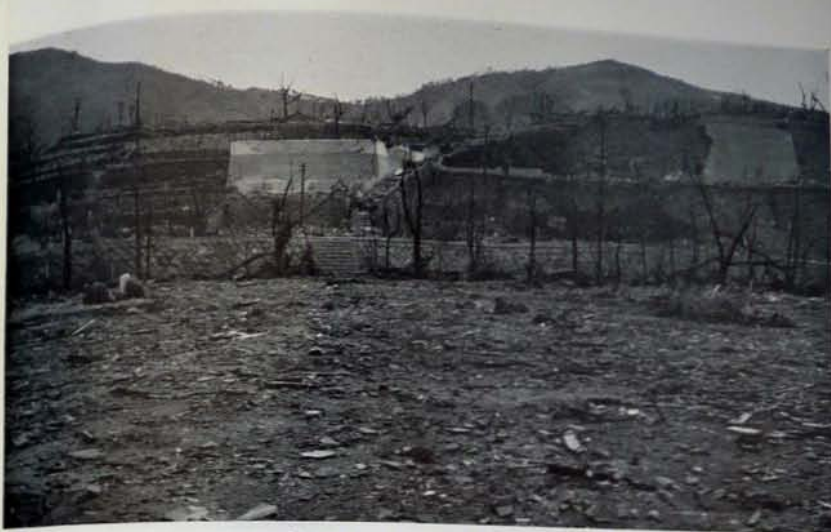
PHOTO 30.—Looking southeast from Ground Zero. This hillside was completely covered with typical Japanese wood frame residences. Note damaged retaining walls.

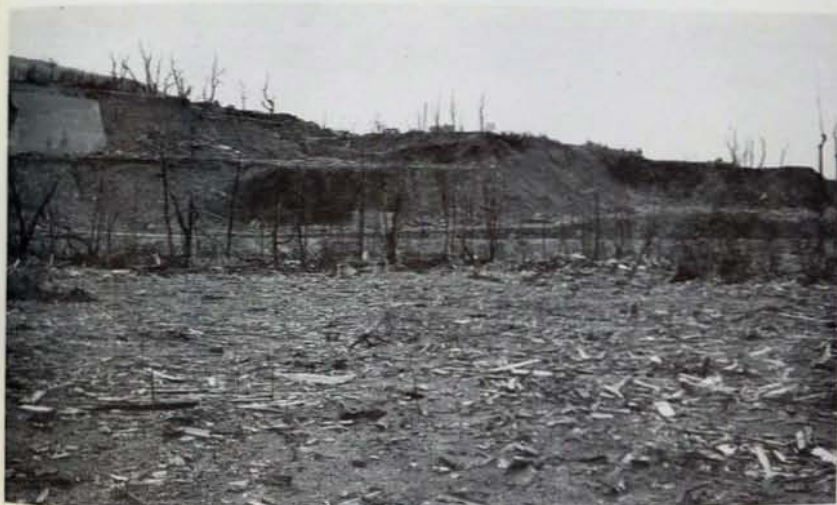
PHOTO 31.—Looking south from Ground Zero. Crude retaining walls were smashed and the hillsides have given away. Ground Zero was established at the air raid shelter in the center of the photo.

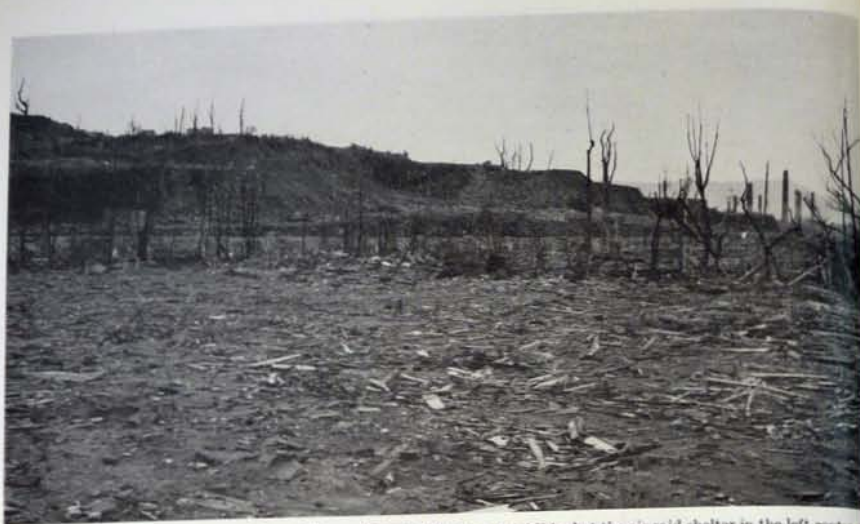
PHOTO 32.—Looking south from Ground Zero. Ground Zero was established at the air raid shelter in the left center of the photo.

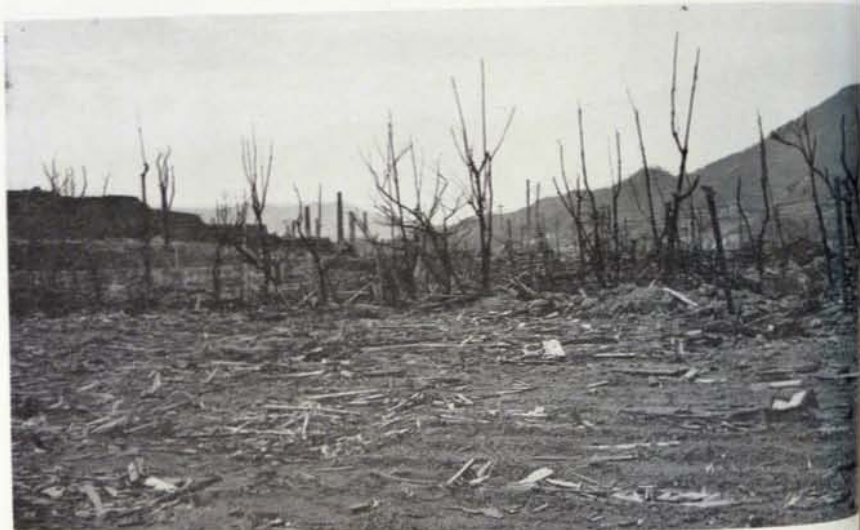
PHOTO 33.—Looking south-southwest from Ground Zero. The stacks of the Mitsubishi Steel and Arms Works (Group 26) can be seen in the distance. To the right of center, can be seen Chinzei High School (Group 18).

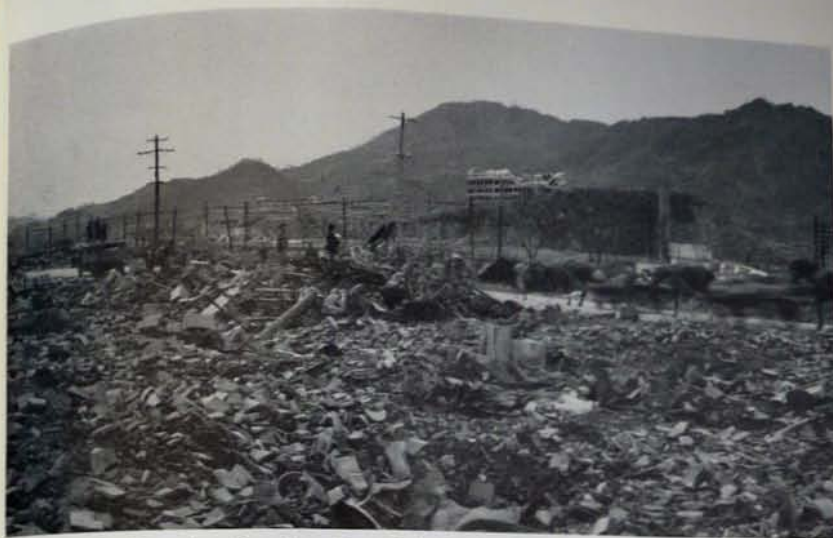
PHOTO 34.—Looking southwest from Ground Zero. In the distance and to the left can be seen Keiho Boys' School (Group 25). Chinzei High School (Group 18) is in the center distance, while slightly to the right can be seen one of the few concrete smoke stacks that was destroyed by blast.

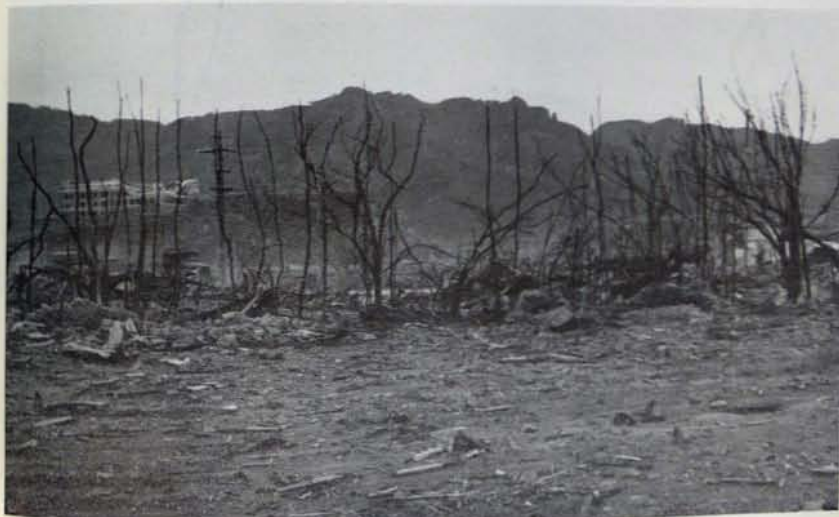
PHOTO 35.—Looking southwest from Ground Zero. Chinzei High School (Group 18), can be seen to the left.

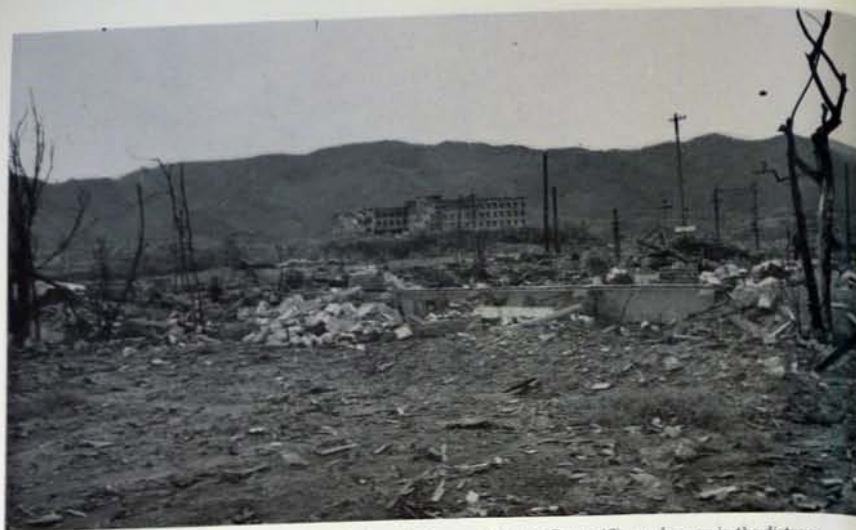
PHOTO 36.—Looking west from Ground Zero. Shiroyama School (Group 16), can be seen in the distance.

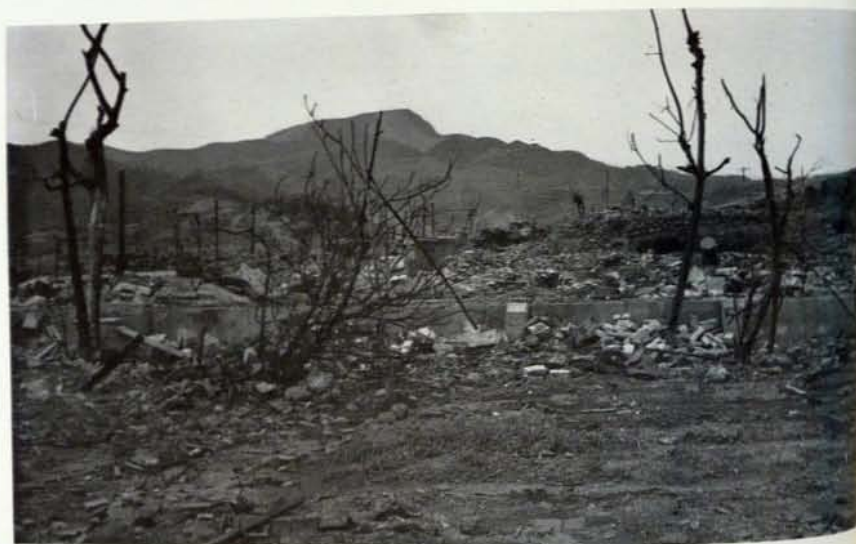
PHOTO 37.—Looking northwest from Ground Zero. Note grass growing in the foreground.

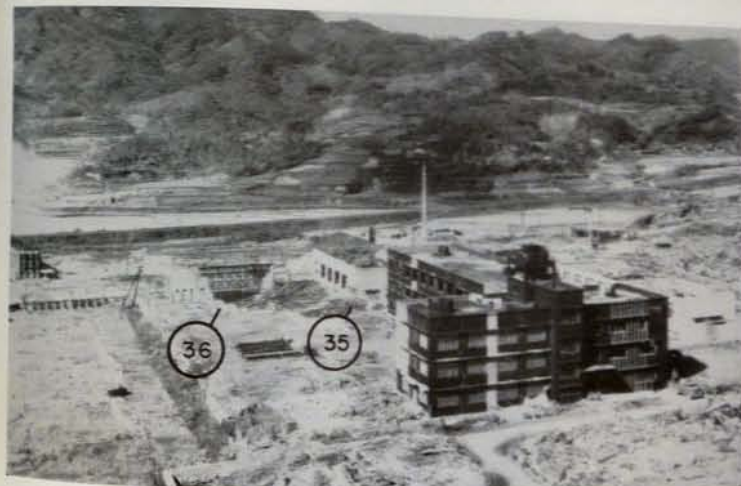
Photo 3.—3,900 feet from GZ. Group 4. Building 28. Aerial view looking northwest.

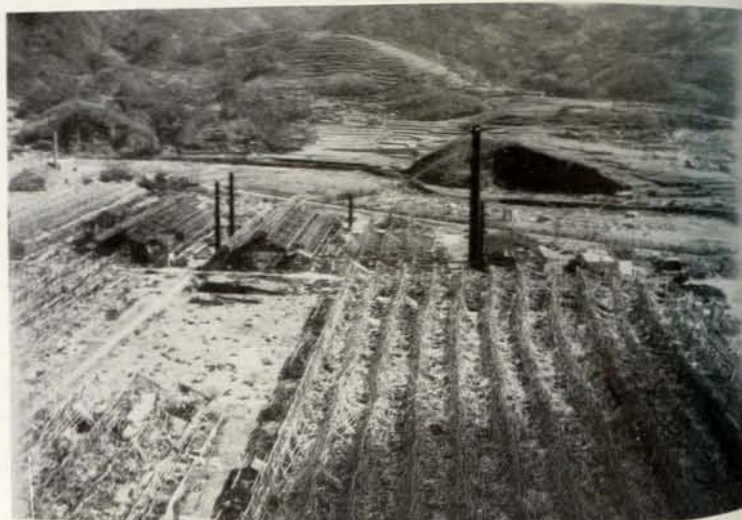
PHOTO 5.—4,500 feet from GZ. Group 4. Building 22. Aerial view east.

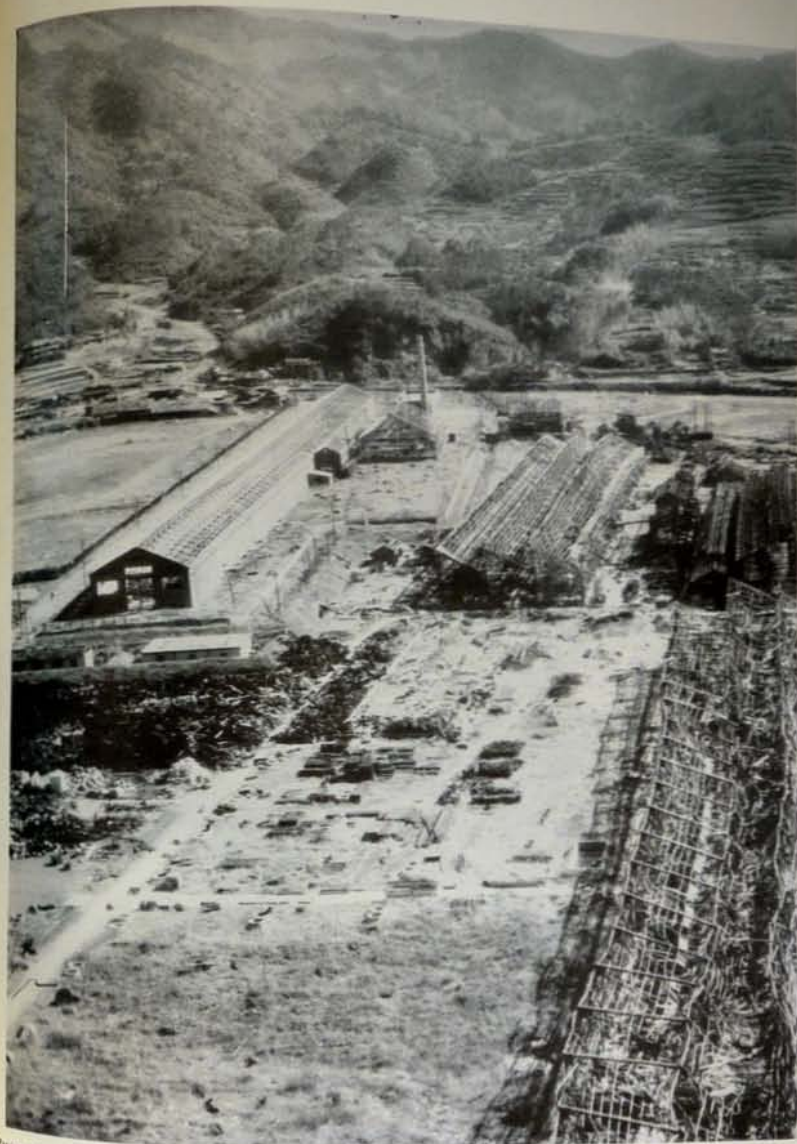
PHOTO 6.—5,100 feet from GZ. Group 4. Aerial view looking east at north portion of Mitsubishi Torpedo Works.

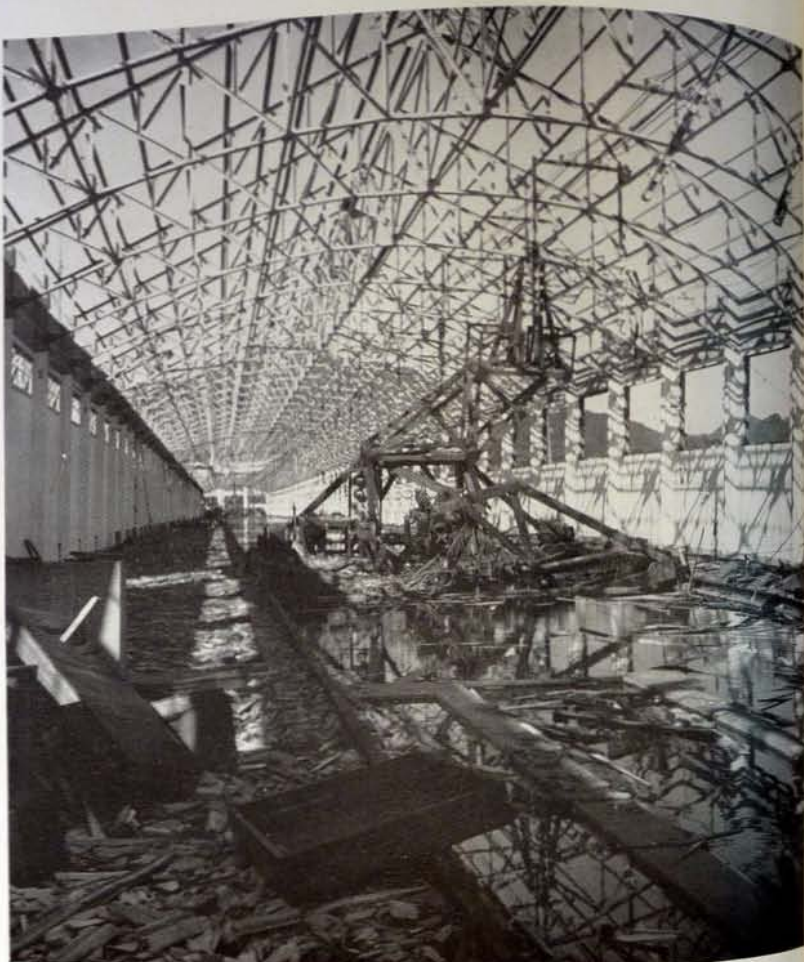
PHOTO 7.—5,500 feet from GZ. Group 4. Building 1, looking west.

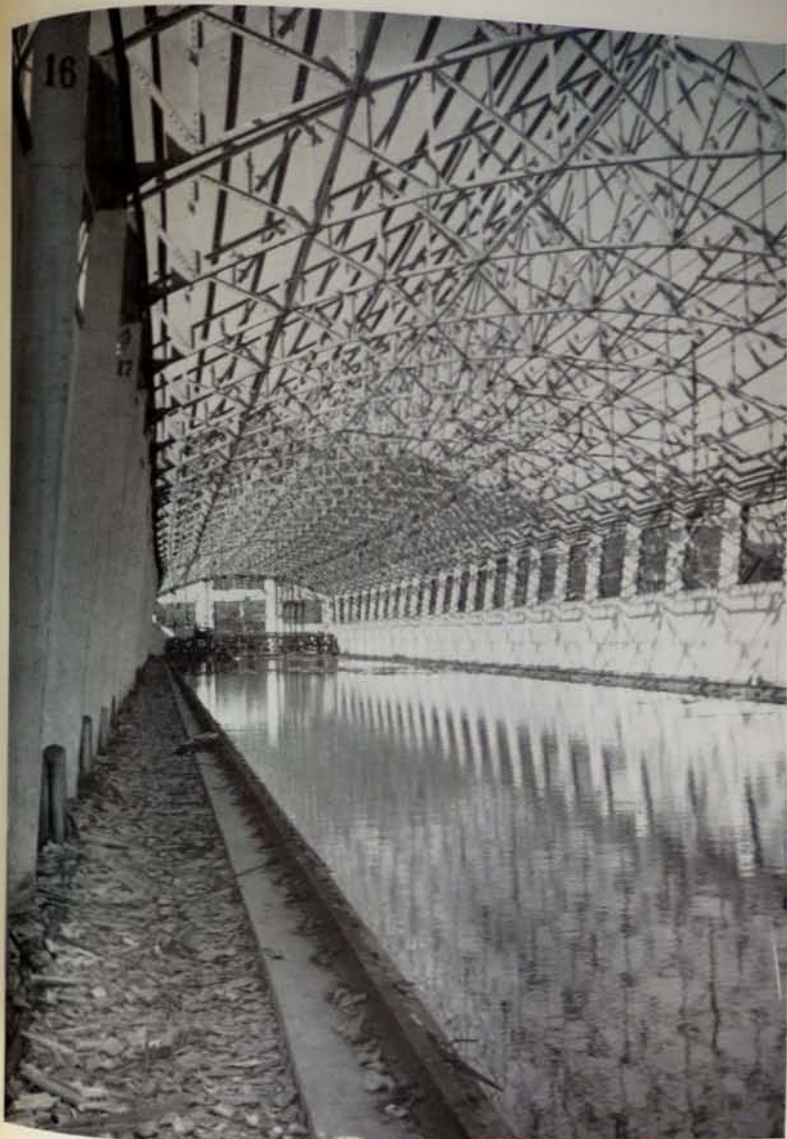
PHOTO 8.—5,500 feet from GZ. Group 4. Building 1, looking west, wall failure.

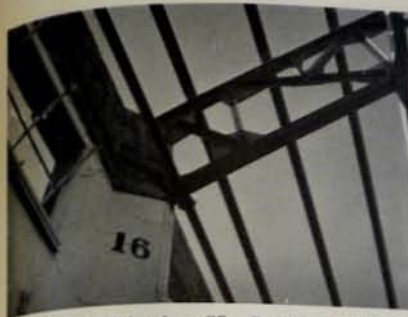
Photo 10.—5,500 feet from GZ. Group 4. Building 1. Typical column failure, south wall inside.

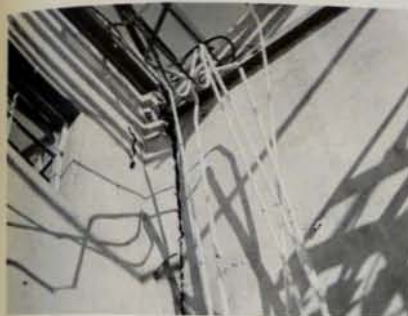
Photo 12.—5,500 feet from GZ. Group 4. Building 1. Separation at Switch House wall.

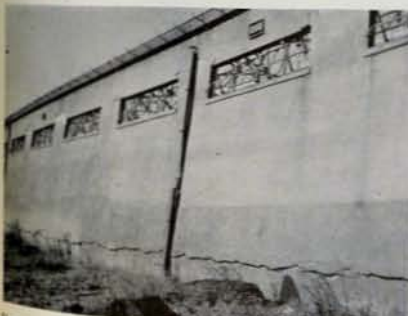
Photo 14.—5,500 feet from GZ. Group 4. Building 1. Typical wall failure, top and bottom.

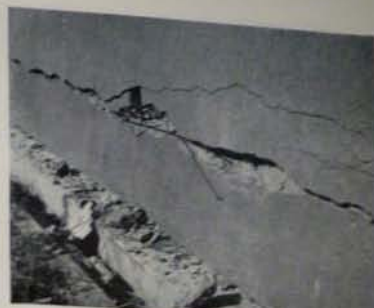
Photo 11.—5,500 feet from GZ. Group 4. Building 1. Typical wall failure bottom of south wall outside.

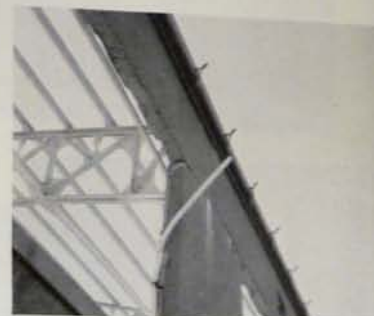
Photo 13.—5,500 feet from GZ. Group 4. Building 1. Crack in north wall looking southwest.

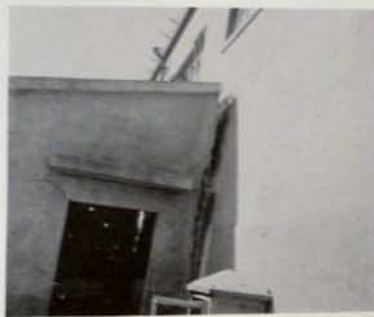
Photo 15.—5,500 feet from GZ. Group 4. Building 1. Separation at Pump House wall.

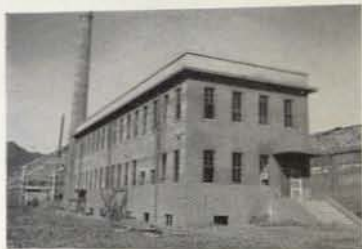
PHOTO 17.—5,400 feet from GZ. Group 4. Building 3. Looking northwest.

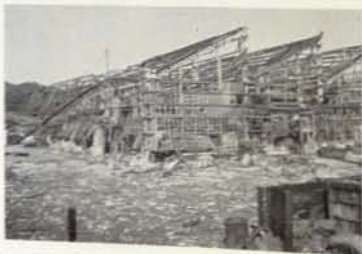
PHOTO 19.—5,100 feet from GZ. Group 4. Building 4. Looking northwest.

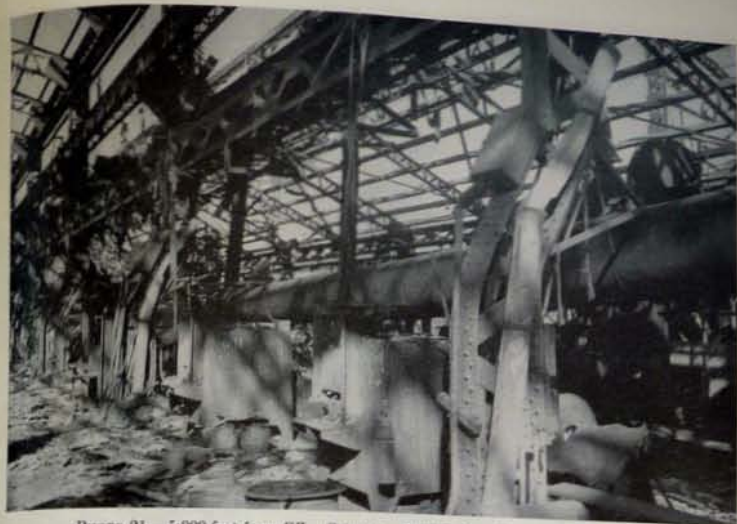
PHOTO 21.—5,000 feet from GZ. Group 4. Building 5. Main columns looking west.

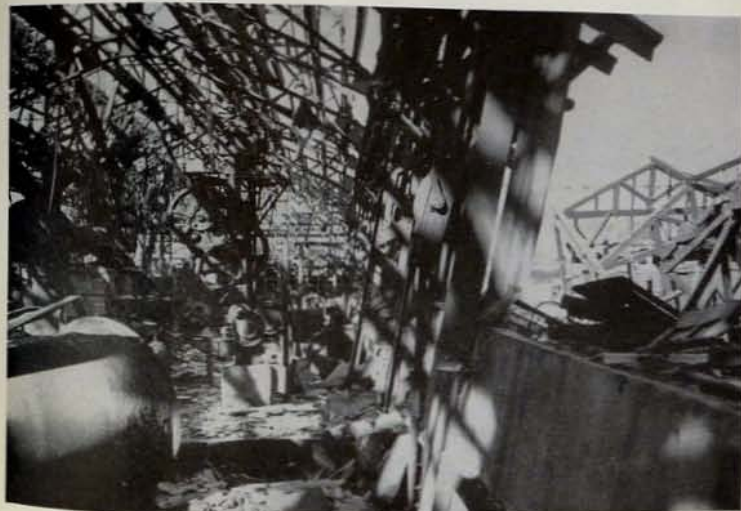
PHOTO 22.—5,000 feet from GZ. Group 4. Building 5. North row of columns, looking west.

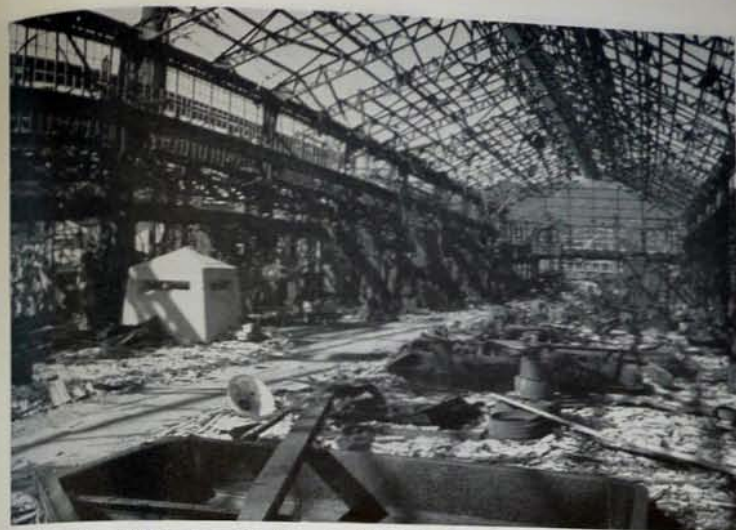
PHOTO 24.—5,000 feet from CZ. Group 4. Building 5. General features and equipment, looking west.

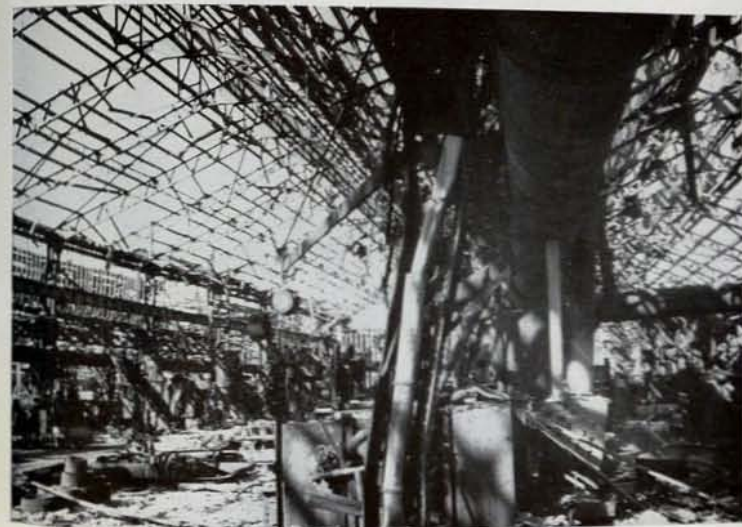
PHOTO 25.—5,000 feet from GZ. Group 4. Building 5. General features and equipment, looking west.

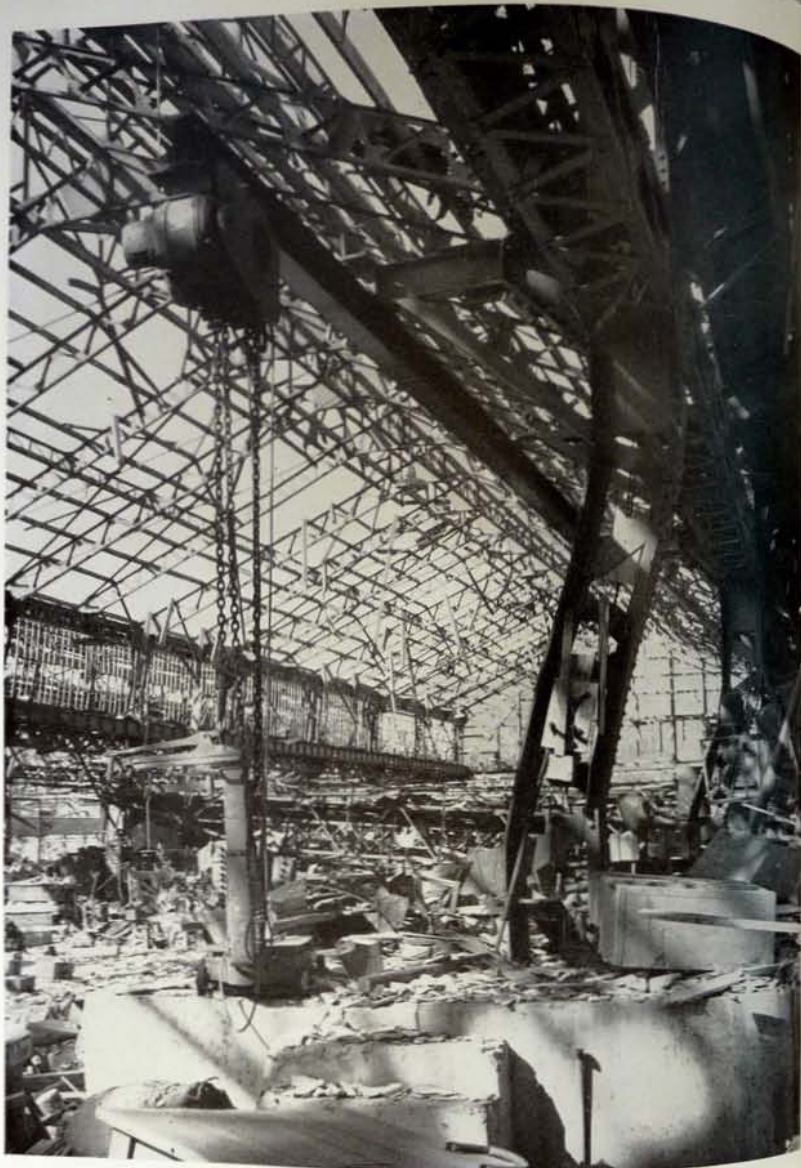
PHOTO 26.—4,800 feet from GZ. Group 4. Building 5A, looking southwest.

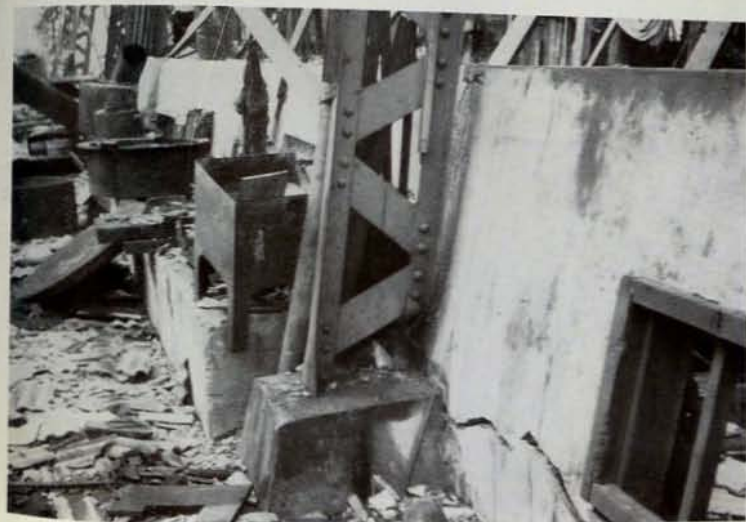
PHOTO 28.—5,000 feet from GZ. Group 4. Building 5. Column 4-A.

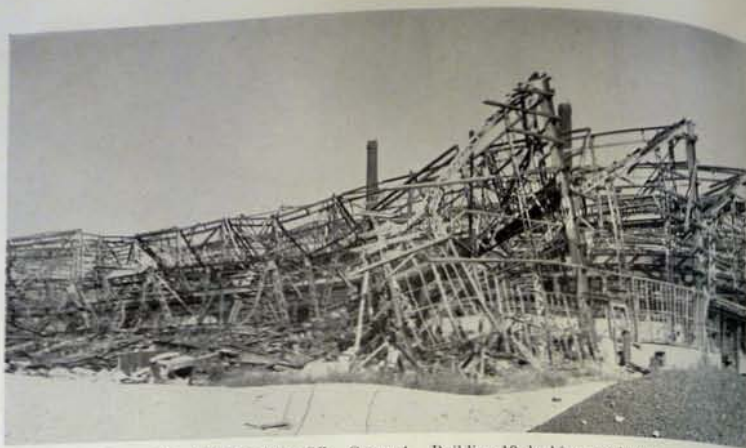
PHOTO 29.—4,600 feet from GZ. Group 4. Building 10, looking northwest.

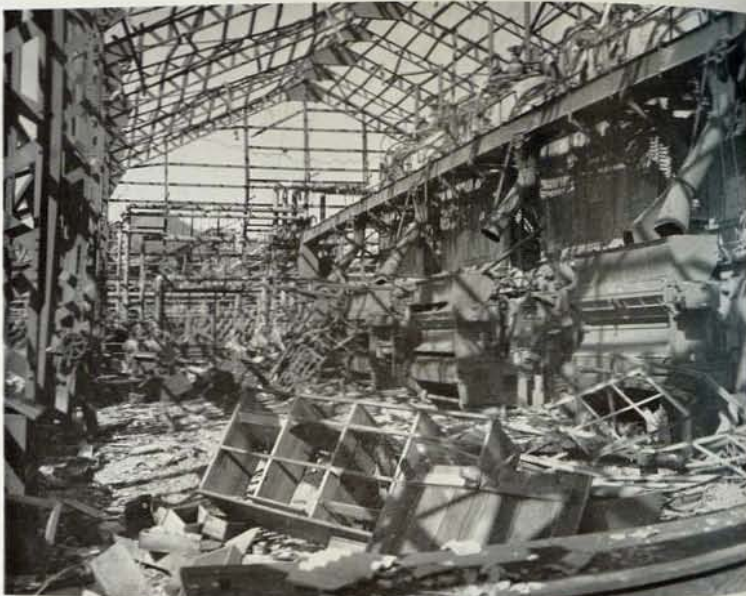
PHOTO 30.—4,400 feet from GZ. Group 4. Building 11, looking west.

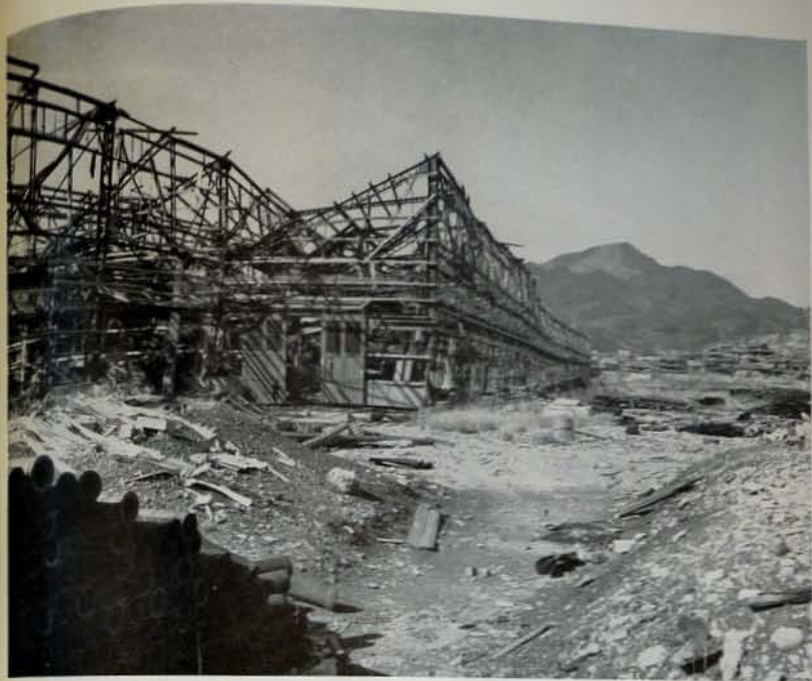
PHOTO 31.—5,100 feet from GZ. Group 4. Building 20, looking northwest.

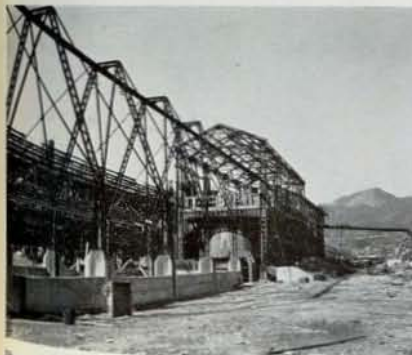
Remarks: Figure 7; Photos 31 and 35.

PHOTO 32.—4,800 feet from GZ. Group 4. Buildings 7, 8, and SA looking southwest.

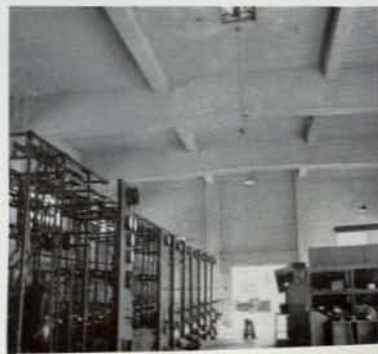
Remarks: Figure 5; Photo 33.

PHOTO 33.—4,300 feet from GZ. Group 4. Building 13, structural features and equipment looking east.

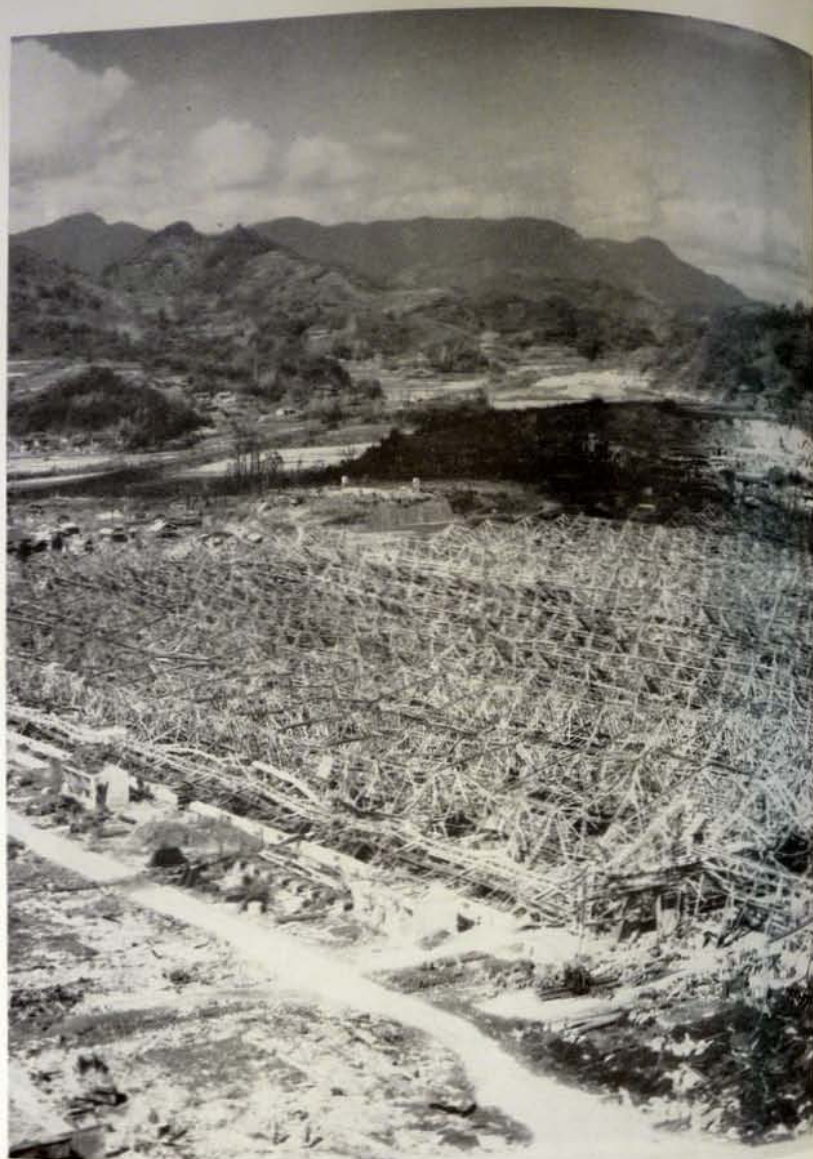
PHOTO 41.—4,500 feet from GZ. Group 4. Building 22. Aerial view looking northwest.

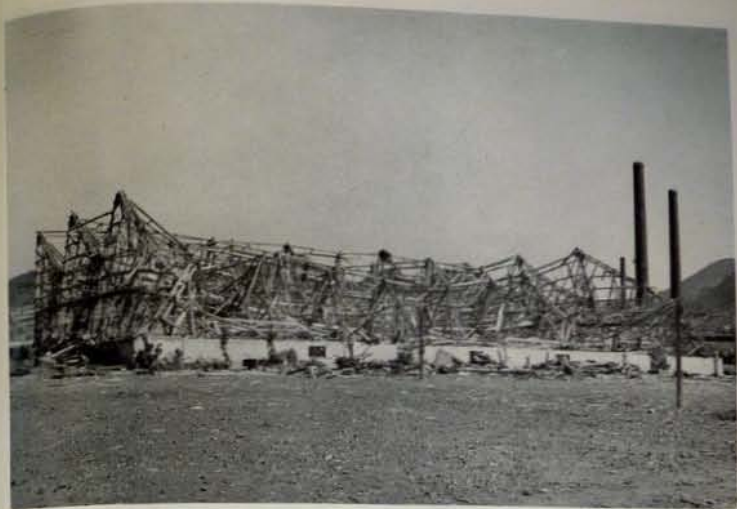
Construction	Damage			Description of damage
	Structural (percent)	Superficial (percent)	Cause	
Roof: Corrugated asbestos on wood sheathing and purlins.	0	100	Blast	No fire. Building canted and collapsed to north. Some columns still standing but all are bent. Photo 42.
Trusses: Steel	100	0	do	
Columns: Steel	100	0	Blast	
First floor: Reinforced concrete	0	0		No fire. Building canted and collapsed to north. Some columns still standing but all are bent. Photo 42.
Foundation: Reinforced concrete	0	0		
Exterior walls: Corrugated asbestos on wood nailers.	0	100	Blast	
Windows: Steel sash	0	100	do

Remarks: Figure 9; Photo 42.

PHOTO 42.—4,100 feet from GZ. Group 4. Building 25, looking northeast.

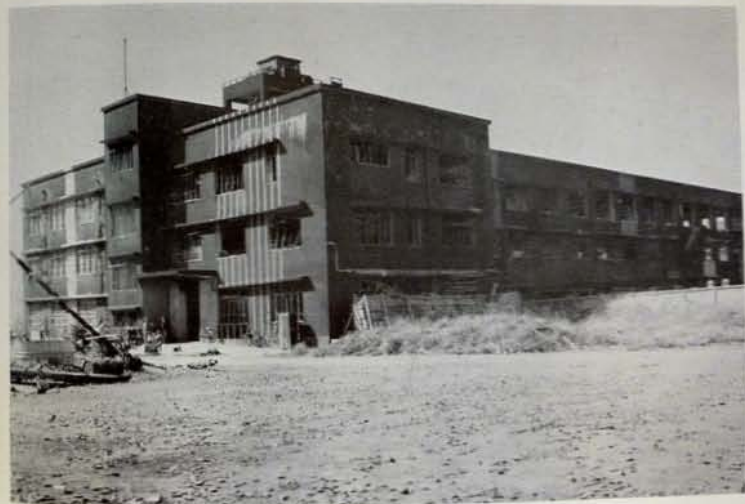
Remarks: Earthquake-resistant construction. Figure 5; Photos 43, 44, 45, 46, 47, 49, and 53.

PHOTO 43.—3,900 feet from GZ. Group 4. Building 28, looking southwest.

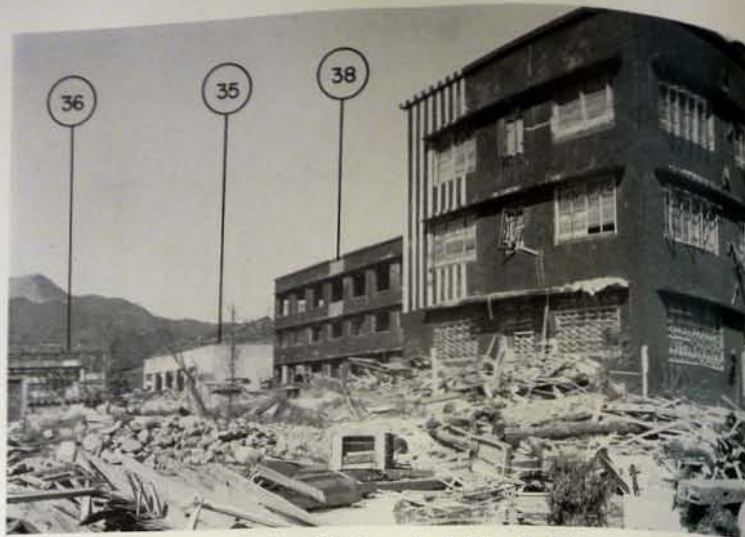
PHOTO 44.—3,900 feet from GZ. Group 4. Building 28, looking northwest.

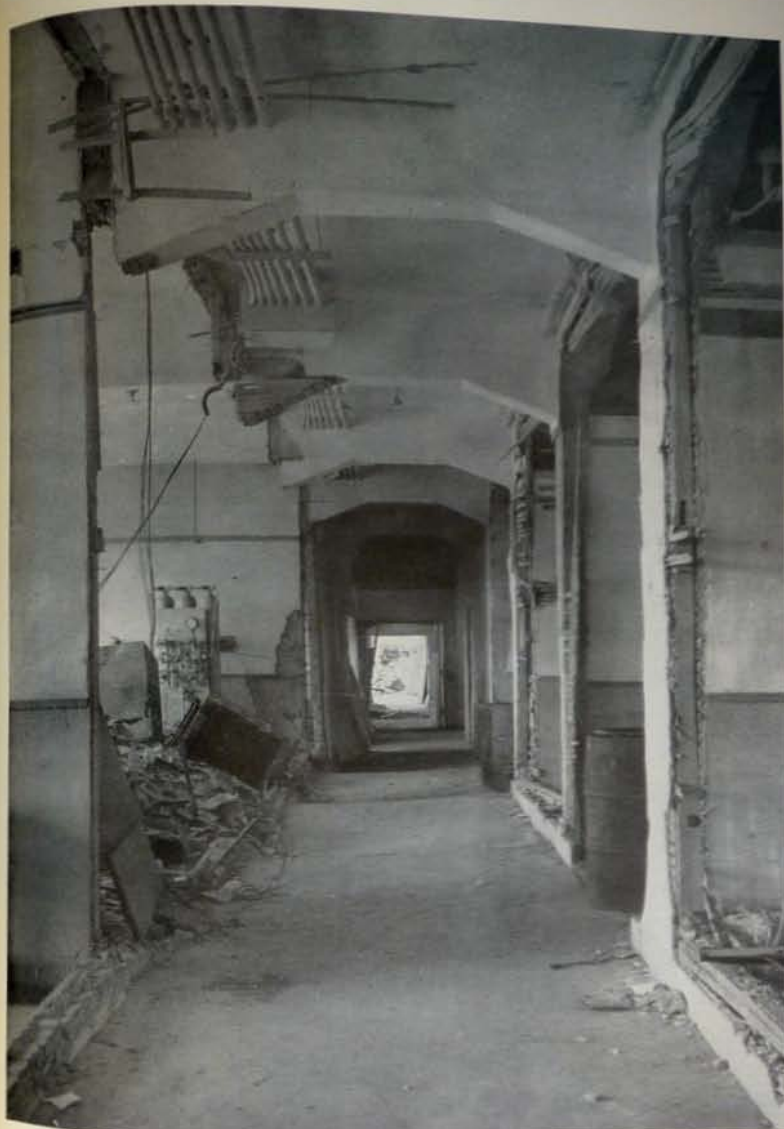
PHOTO 46.—3,900 feet from GZ. Group 4. Building 28, first floor buckled slab.

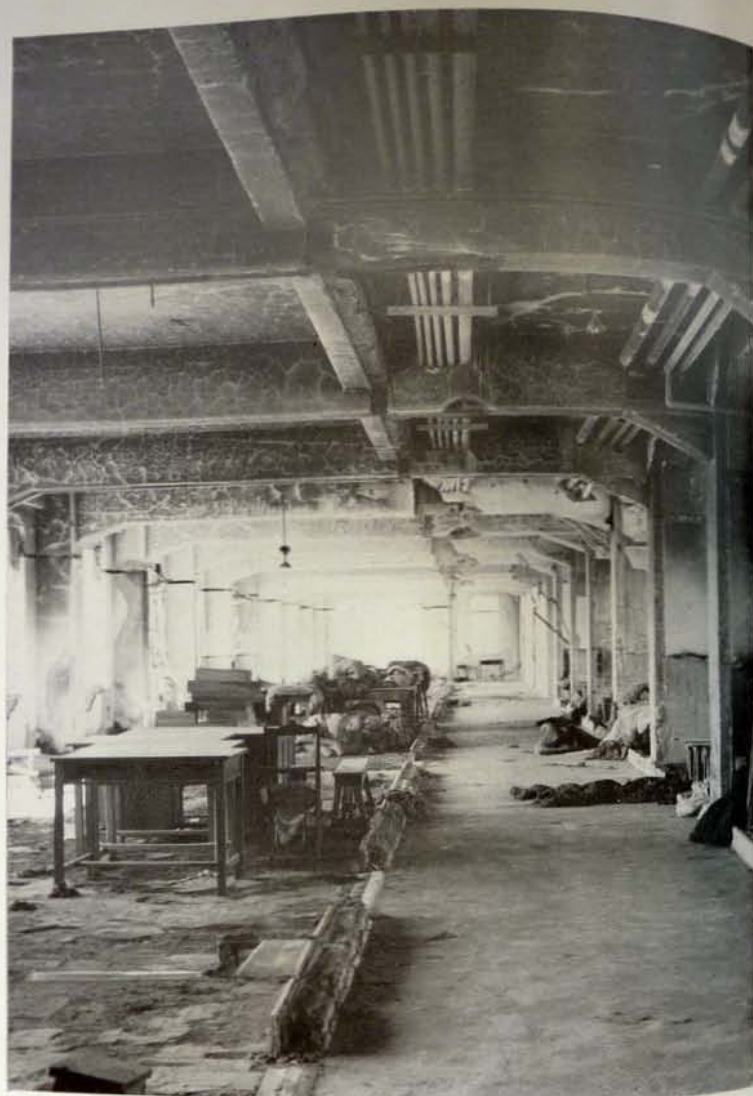
PHOTO 47.—3,900 feet from GZ. Group 4. Building 28, second floor looking west.

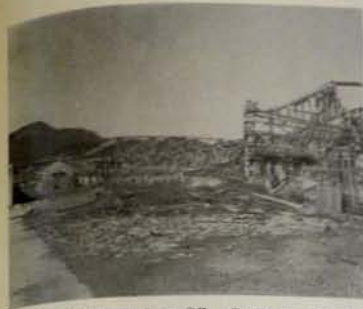
PHOTO 48.—4,200 feet from GZ. Group 4. Building 23, looking northwest.

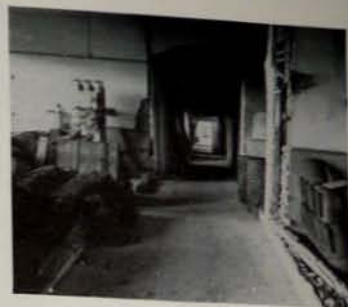
PHOTO 49.—3,900 feet from GZ. Group 4. Building 28, first floor looking west.

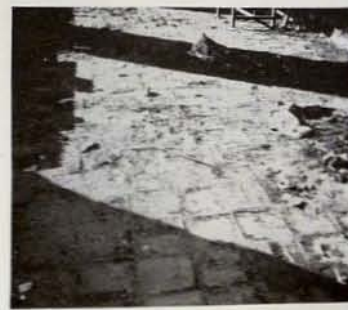
PHOTO 53.—3,900 feet from GZ. Group 4. Building 28, burned flooring.

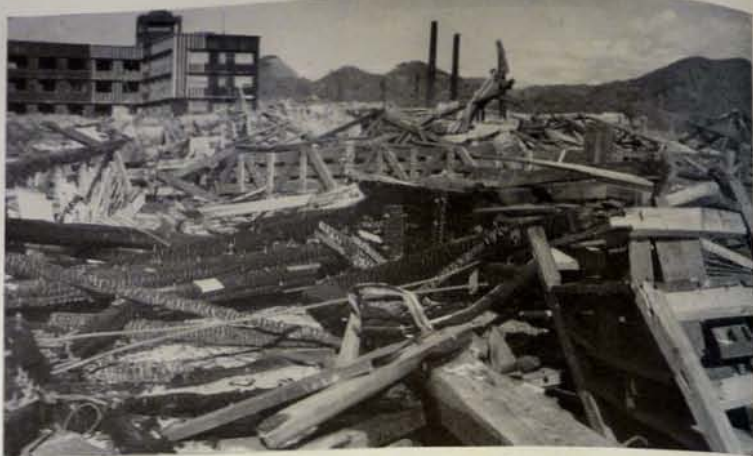
Remarks: Entire building damaged; Photos 54, 55, 56, 57, and 58.

PHOTO 54.—3,200 feet from GZ. Group 5. Building 1. Looking northeast at margin of fire damage.

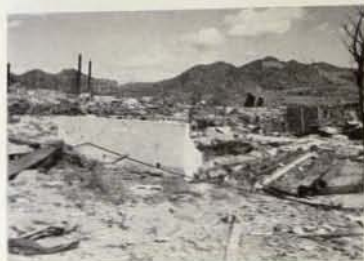
PHOTO 55.—Group 5. Building 1. General view looking northeast.

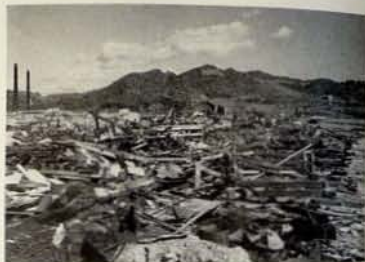
PHOTO 56.—Group 5. Building 1. Looking northeast toward north end.

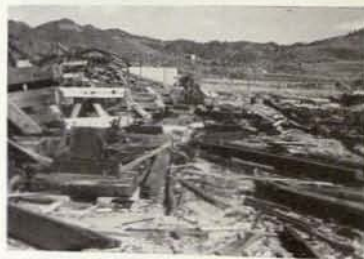
PHOTO 57.—Group 5. Building 1. Typical failure at base of column.

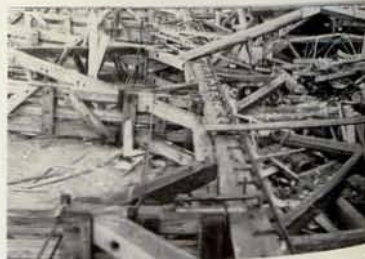
PHOTO 58.—Group 5. Building 1. Flash burns on timber framing.

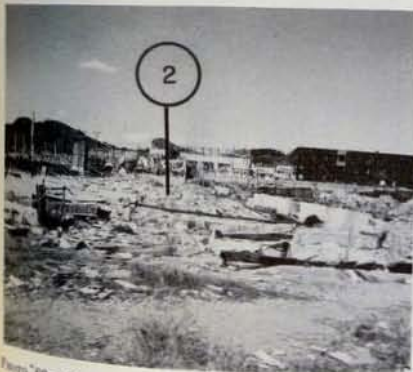
Remarks: Entirely demolished and burned. Photo 60.

PHOTO 60.—Group 5. Building 2. Looking north at debris.

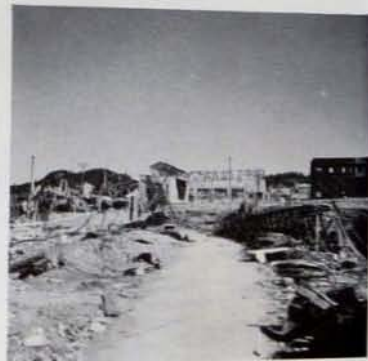
PHOTO 61.—Group 5. Looking north at collapsed distribution towers.

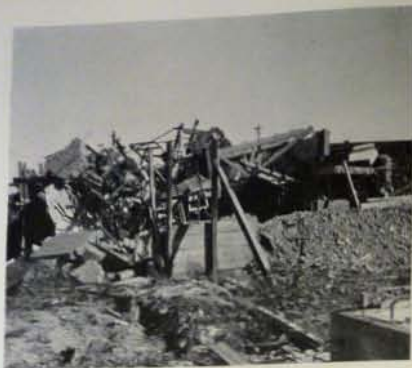
Remarks: Photo 62.

Photo 62.—3,500 feet from GZ. Group 5. Building 3. Collapsed substation.

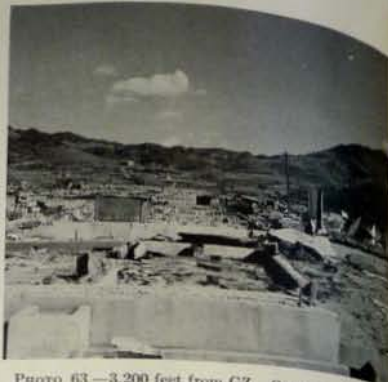
Remarks: Completely demolished, burned and partly cleared away. Photo 63.

Photo 63.—3,200 feet from GZ. Group 5. Building 3. General view looking east.

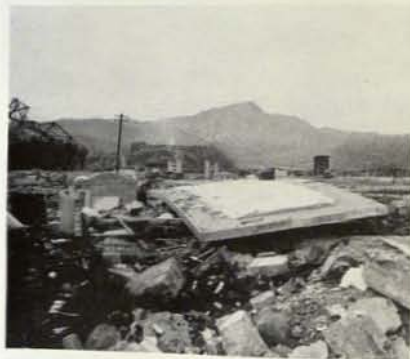
Construction	Damage			Description of damage
	Structural (percent)	Superficial (percent)	Cause	
Roof: North 4/5: probably corrugated asbestos on wood. South 1/5: reinforced concrete slab.	20	80	Blast and fire	Slab overturned and cracked, remainder damaged and burned. Photos 64 and 65.
Trusses: Wood (North 4/5 only)	100	0	do	
Columns: Wood (North 4/5 only)	100	0	do	
First floor: Concrete on earth	0	0		
Foundation: Concrete	0	0		
Exterior walls: North 4/5: CGI or asbestos on wood frame. South 1/5: 4-inch brick.	20	80	Blast and fire	
Interior walls: 4-inch brick (1 partition only).	0	100	Blast	
Windows: NA—probably none	0	0		
Contents: Small finished parts	100	0

Photo 64.—Group 5. Building 7. Roof slab overturned by blast.
